## PROPERTY CONDITION REPORT

**REDWOOD BUSINESS PARK**  
2850 South Redwood Road  
West Valley City, Utah 84119

Date: May 7, 2015  
Partner Project No. 14-130785.18

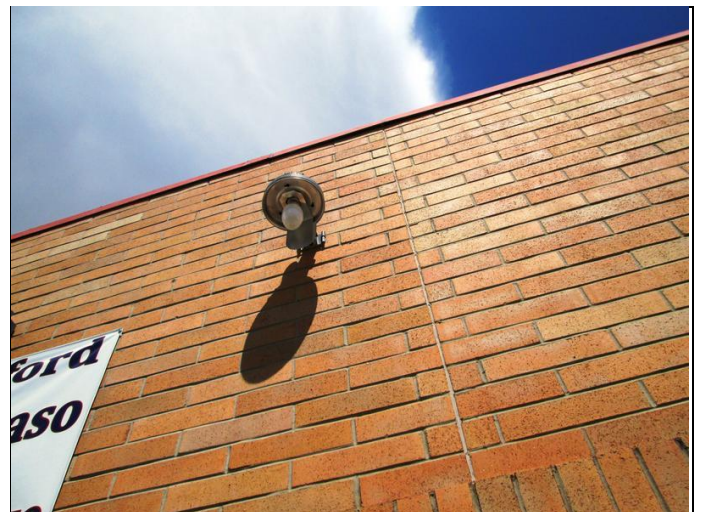
Observed light fixtures appeared to be, and were reported to be, in average overall condition. Two of the scone fixtures appeared damaged. Partner anticipates that the light fixtures will require minimal repair or replacement during the evaluation period that can be addressed as part of routine maintenance.

24. Typical exterior sconce light (this one missing glass housing cover)

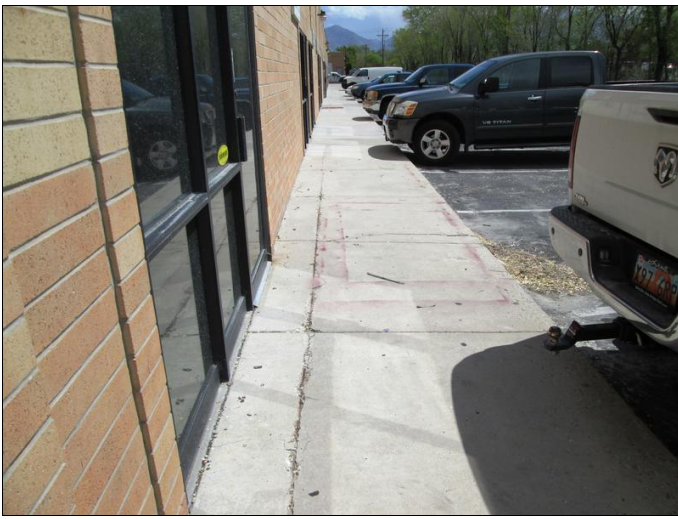
Pedestrian concrete walkways appeared to be in average overall condition. Normal cracking and deterioration of the concrete walks was noted throughout. Partner noted that the sidewalk at the south side of the 2854 Building is cracked along the building perimeter, approximately where the foundation wall aligns below. Similarly, the north side of the 2852 Building is cracked along the building perimeter. None of the cracking viewed was substantial enough to create a tripping hazard; however, the cracks should be periodically monitored for the development of tripping hazards. Minor sectional replacements may be required over time; however, this is considered to be routine maintenance.

25. Typical sidewalk along the south side of 2854 Building

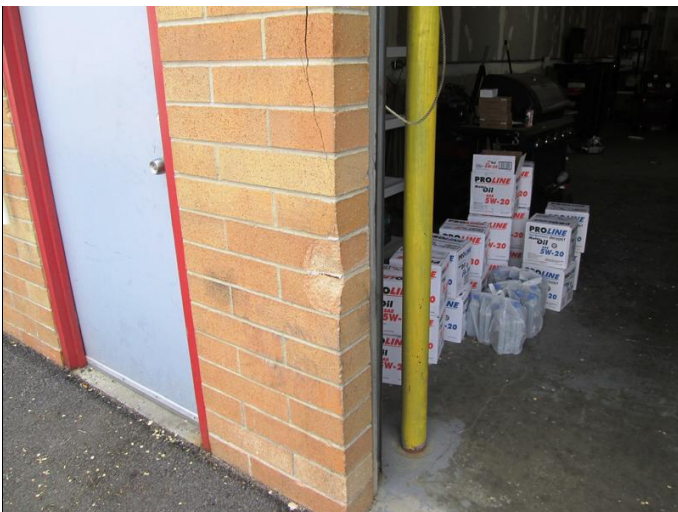
35. Impact damage and cracked masonry at suite C2's roll-up door

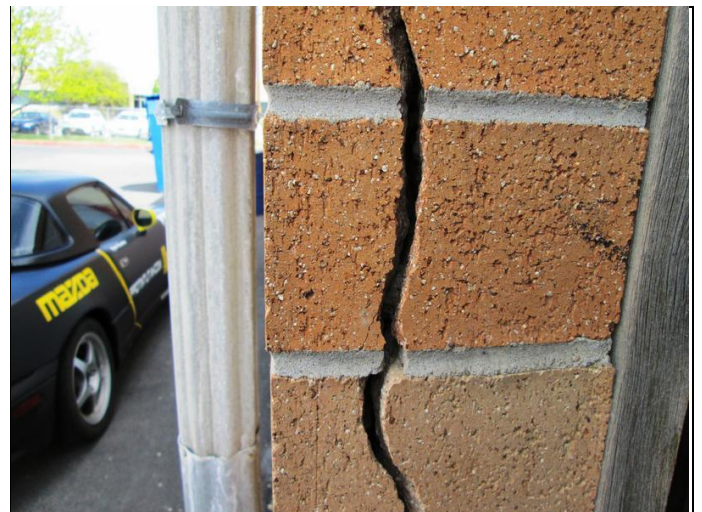
36. Masonry crack at suite A9's roll-up door

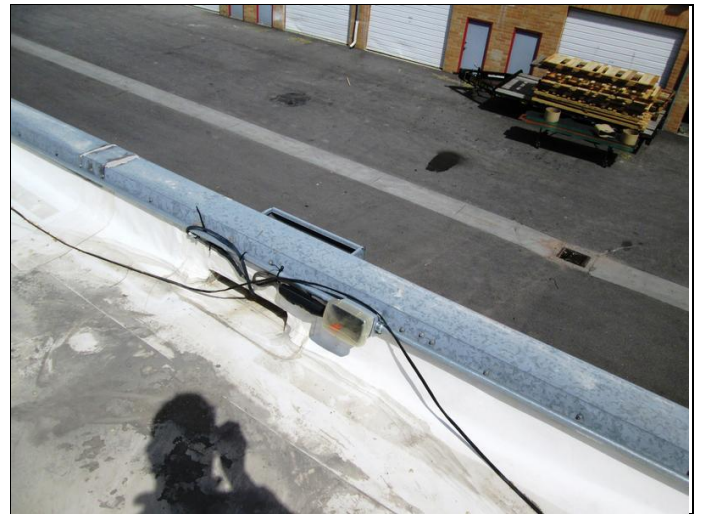
45. Duct tape patch at roof cap

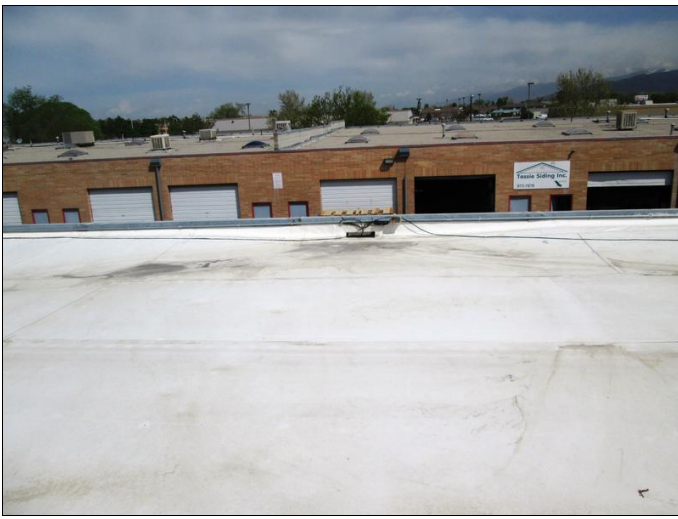
49. Roof membrane

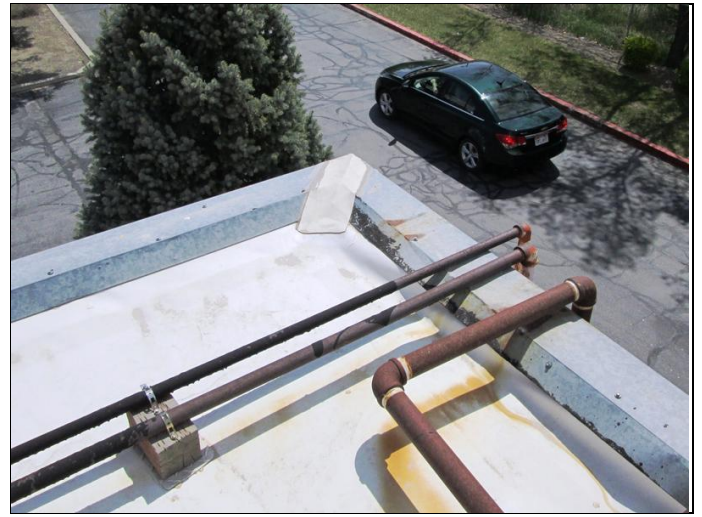
56. Roof patch over parapet cap at Building 2850 southeast corner

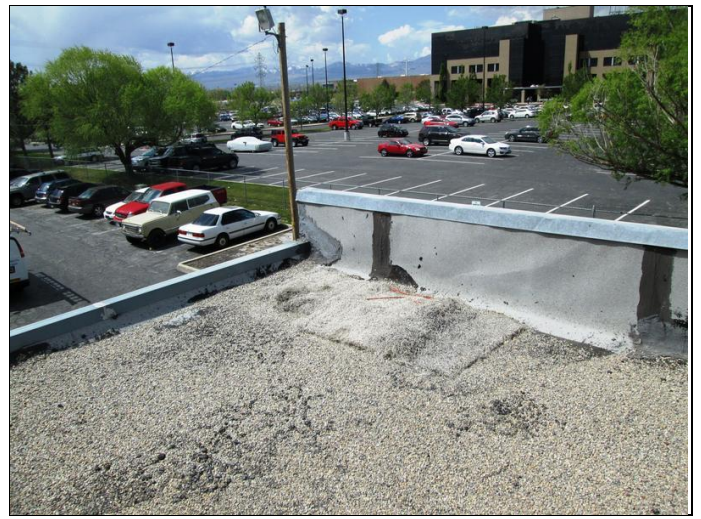
68. Patches at Building 2852 west parapet wall

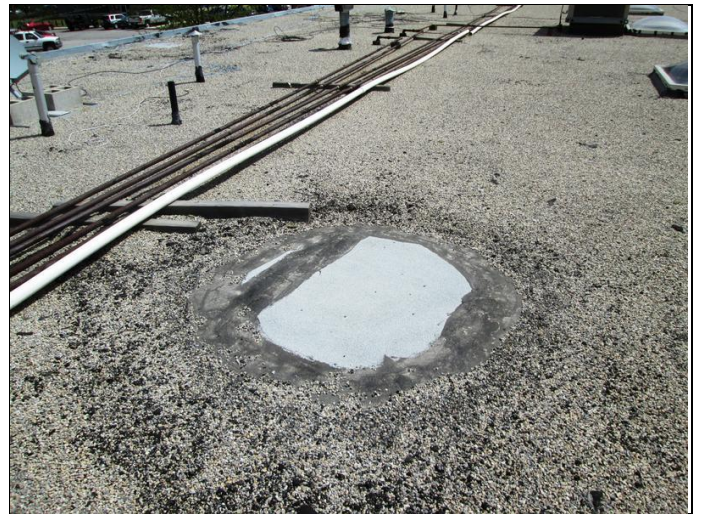
70. Sheet metal patch location on the Building 2852 roof

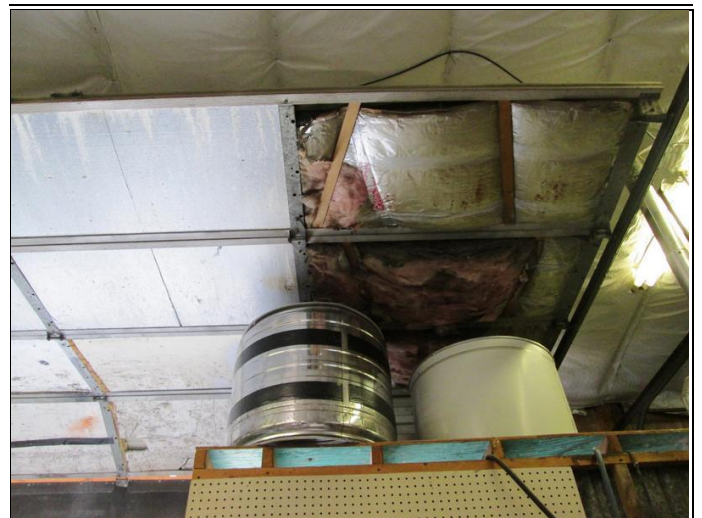
76. Damaged roll-up sectional door panels on inside face
