## PROPERTY CONDITION REPORT

**REDWOOD BUSINESS PARK**  
2850 South Redwood Road  
West Valley City, Utah 84119

Date: May 7, 2015  
Partner Project No. 14-130785.18

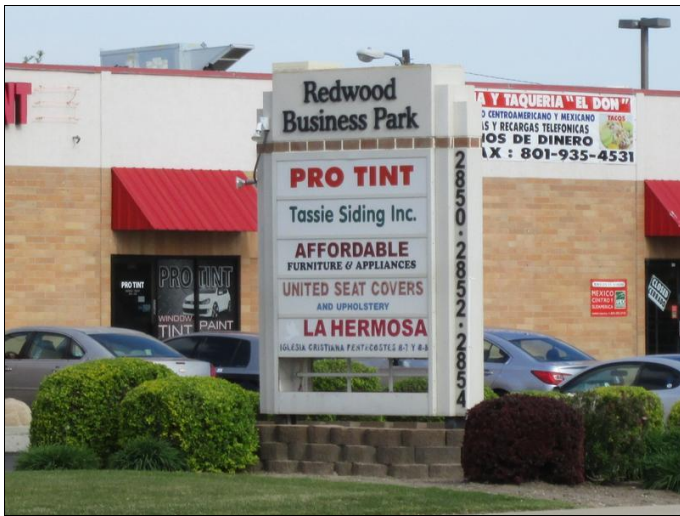
1. Monument sign

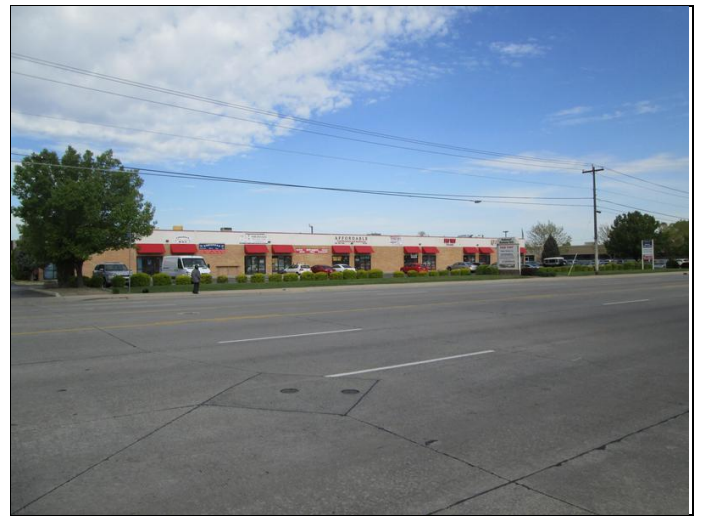
2. View of the subject property across Redwood Road

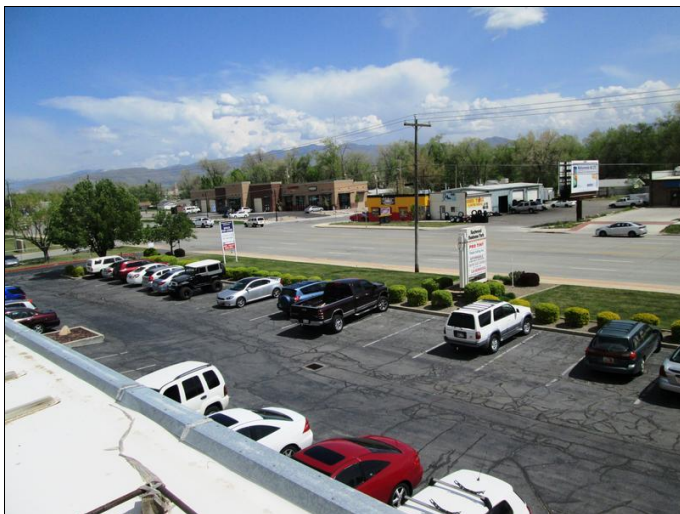
3. View of the parking lot along Redwood Road from roof of 2850 Building

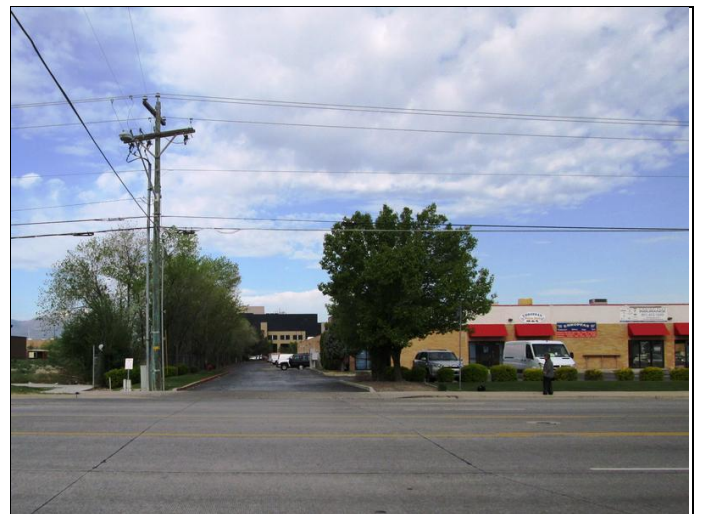
4. View west of the south entry drive off Redwood Road

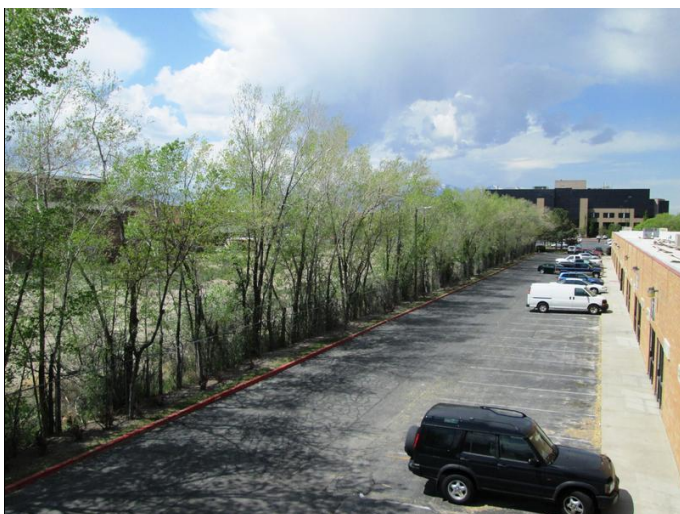
5. View southwest of parking area south of 2854 Building

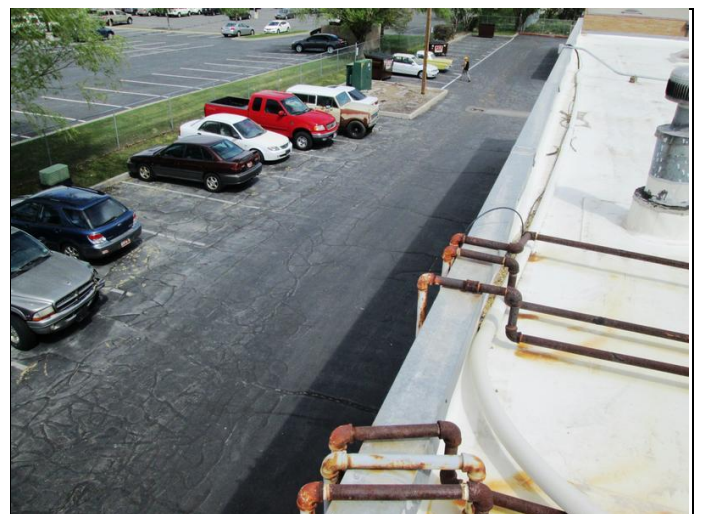
6. View northeast of parking along the north property line

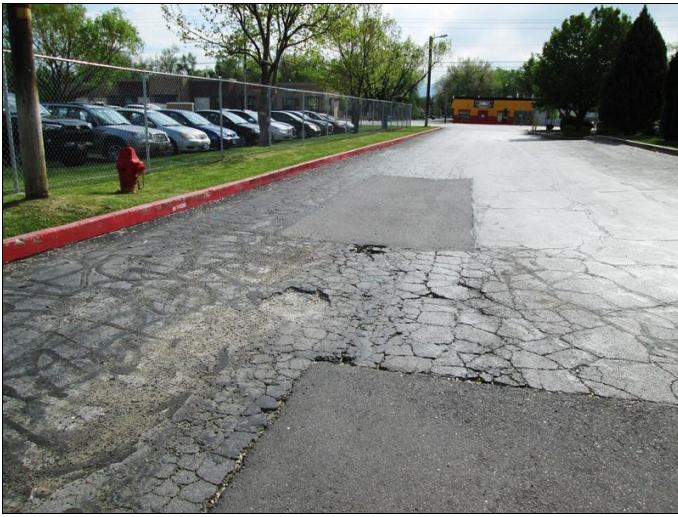
7. View east along the north property line (left)

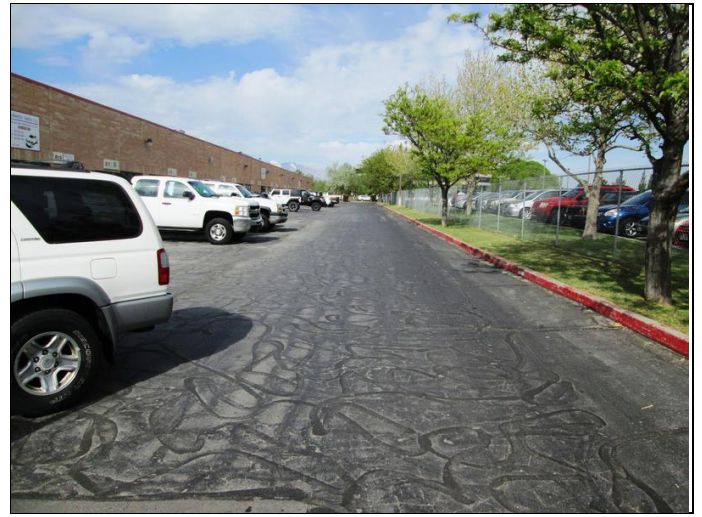
8. View west along the north property line (right)

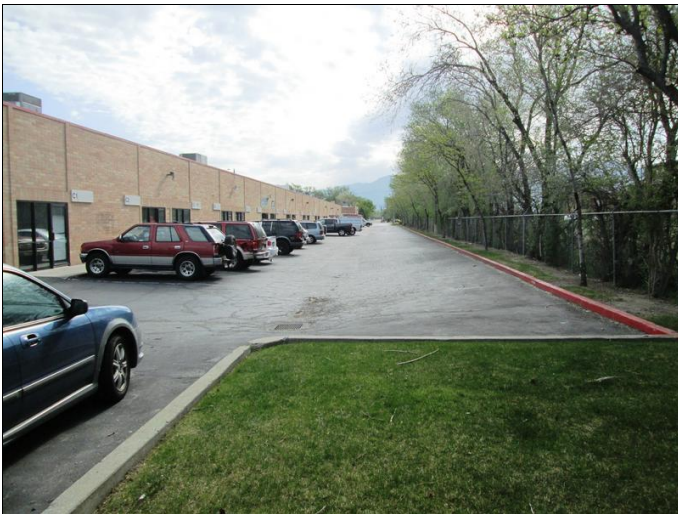
9. View east along the south property line (right)

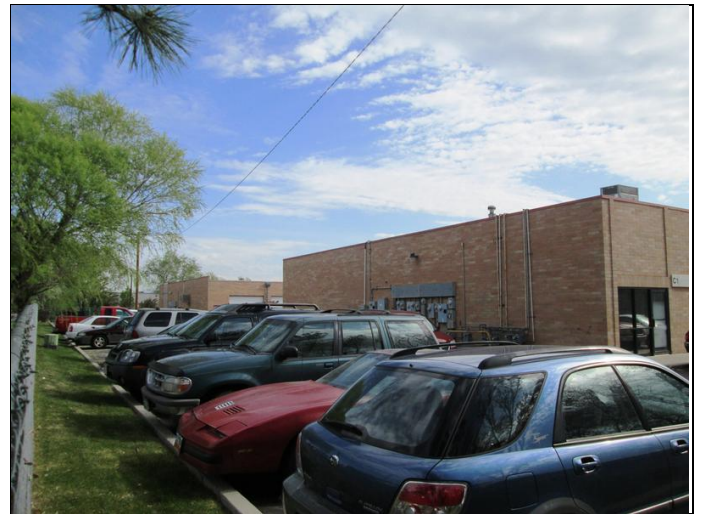
10. View northeast along the west property line (left)

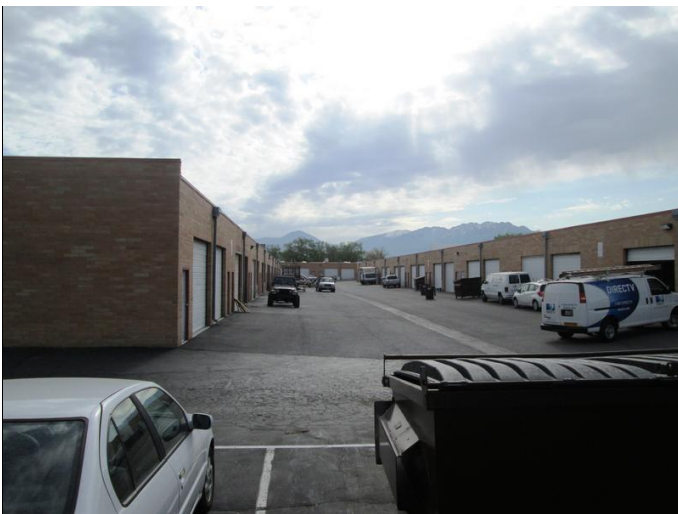
11. View east along the central drive lane

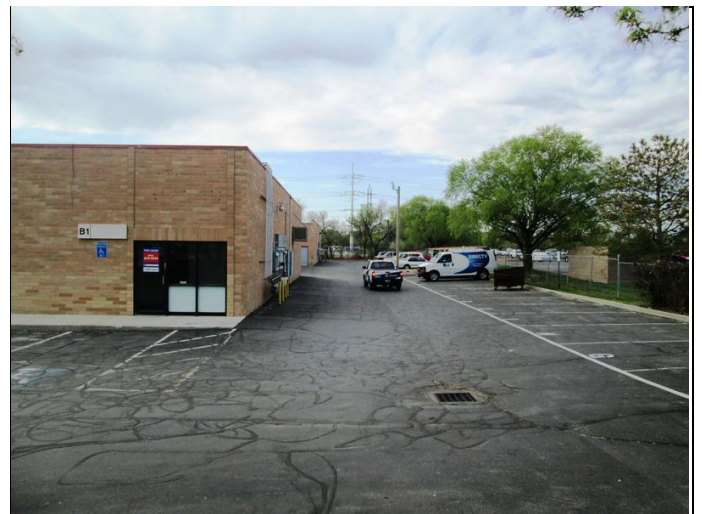
12. View south along the west property line (right)

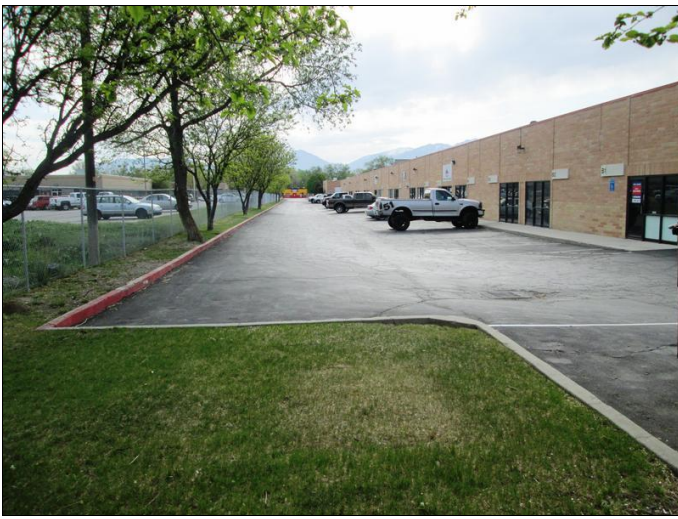
13. View east along the north property line (left)

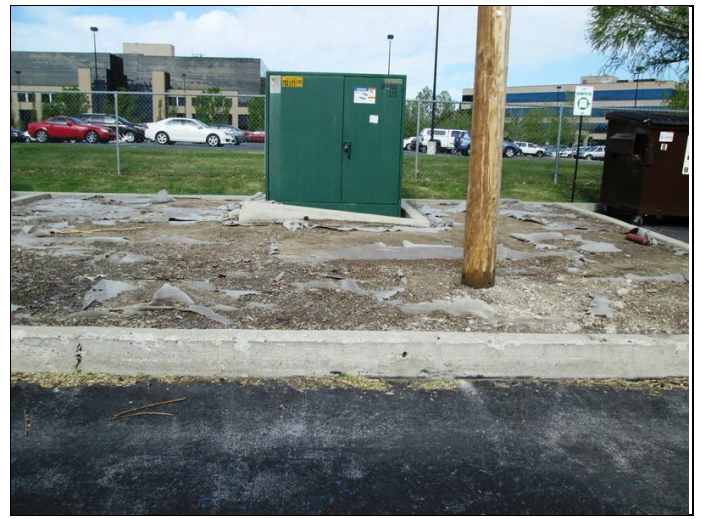
14. Transformer at west property line, midway

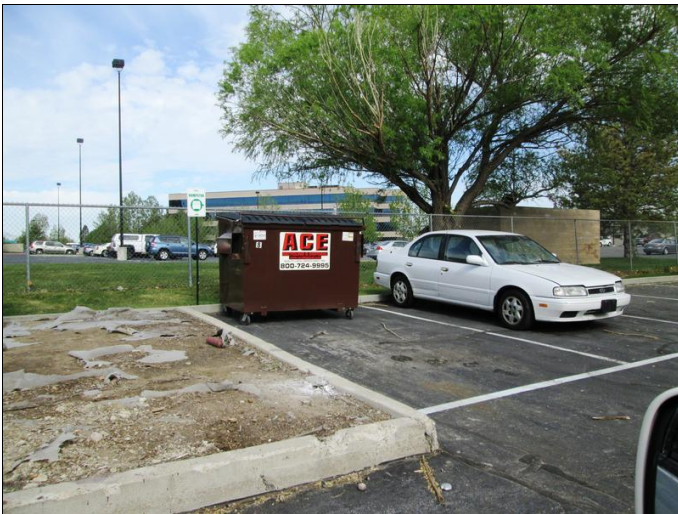
15. Dumpster "stalls" at north end of the west property line

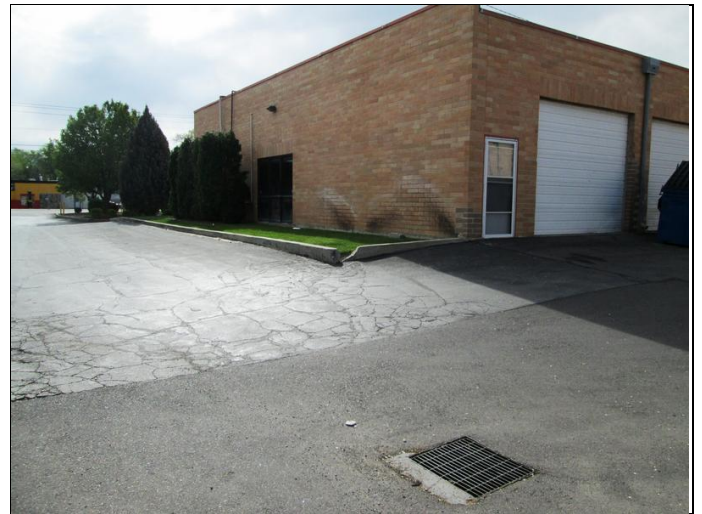
16. View southeast towards Building 2850 northwest corner

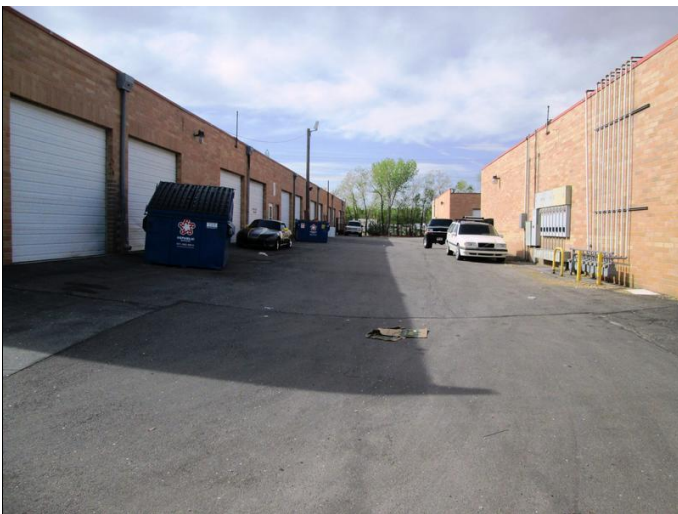
17. View south at rear the of 2850 Building (left)

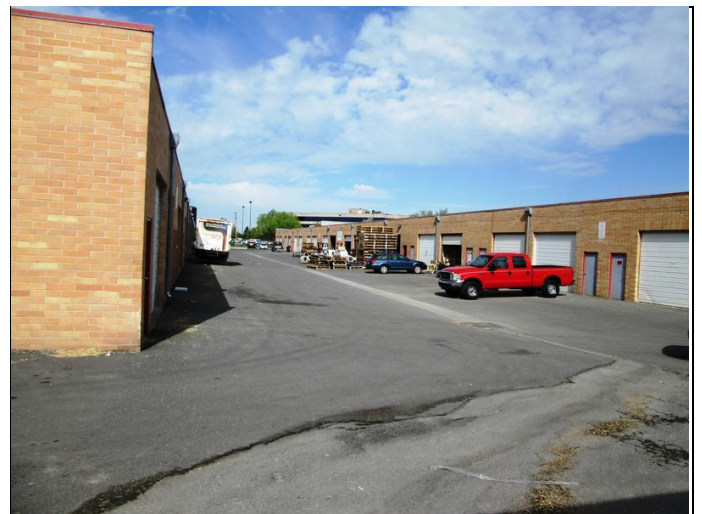
18. View west along central access drive from the rear of 2850 Building (2854 Building at left and 2852 Building at right)

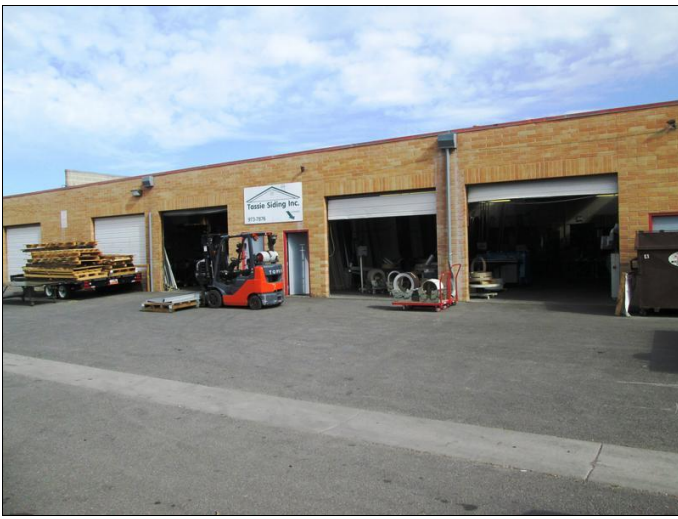
19. View of roll-up doors to suites occupied by Tassie Siding Inc. (B9-B14)

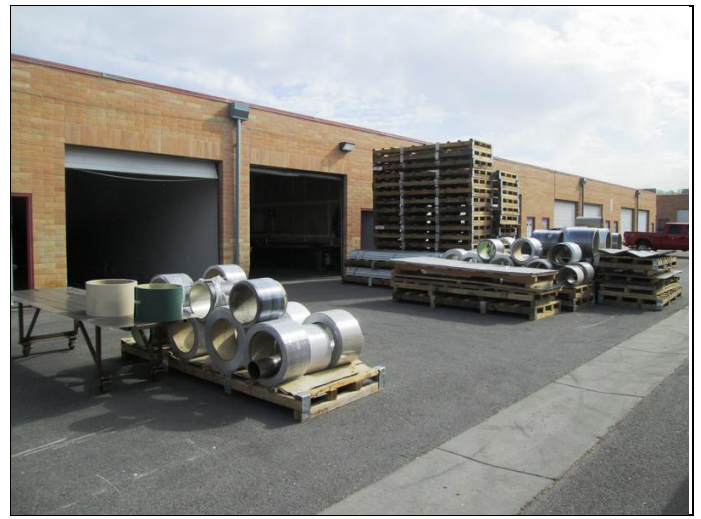
20. View northeast to suites occupied by Tassie Siding Inc.

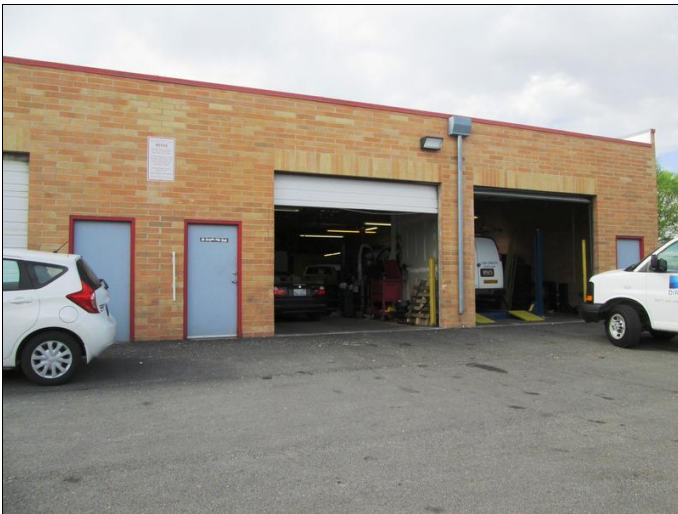
21. View of suites occupied by Tire Hunter, Inc. (C1/C2)

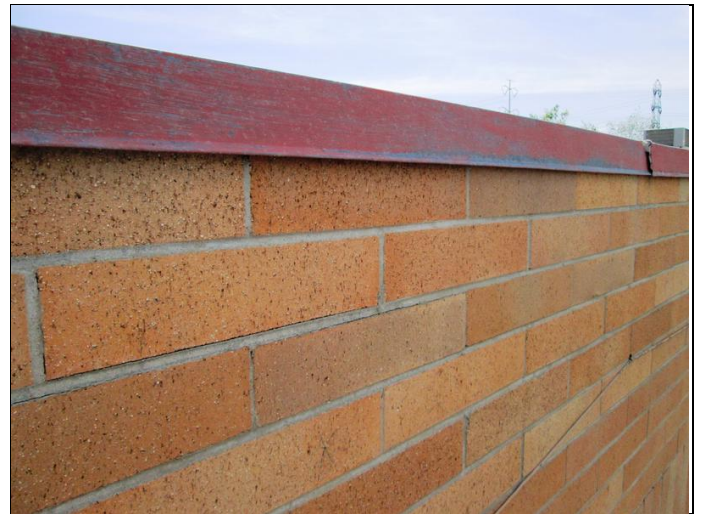
22. Parapet cap detail at the 2854 Building

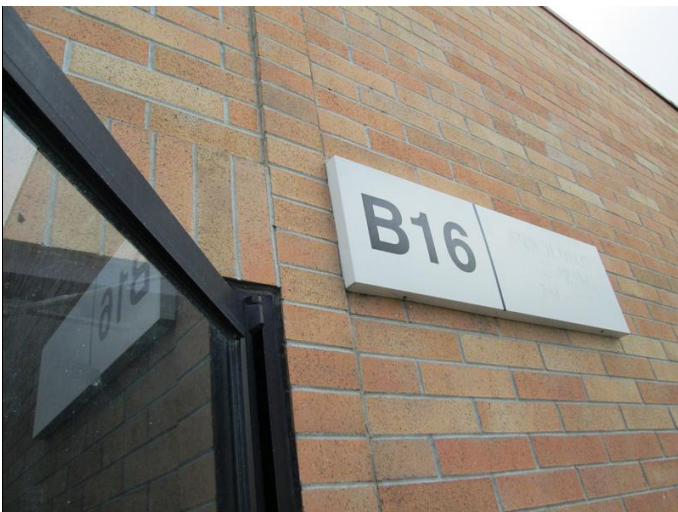
23. Typical tenant identification sign at the 2852 and 2854 Buildings

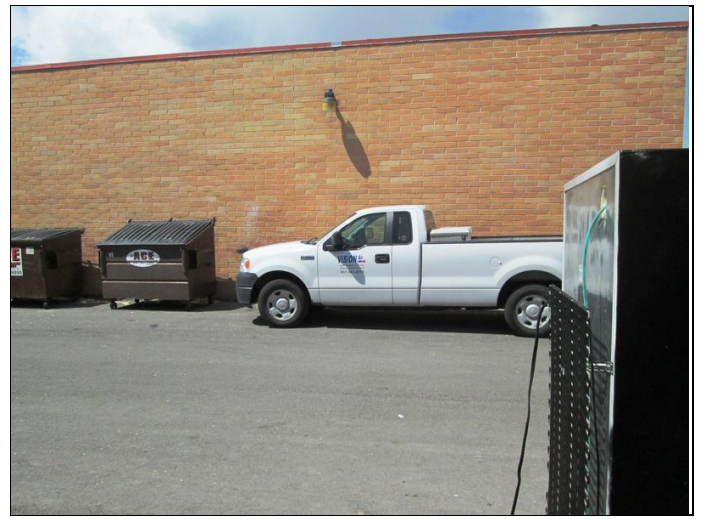
26. Dumpsters located at the east end of the 2854 Building for use by the 2850 tenants

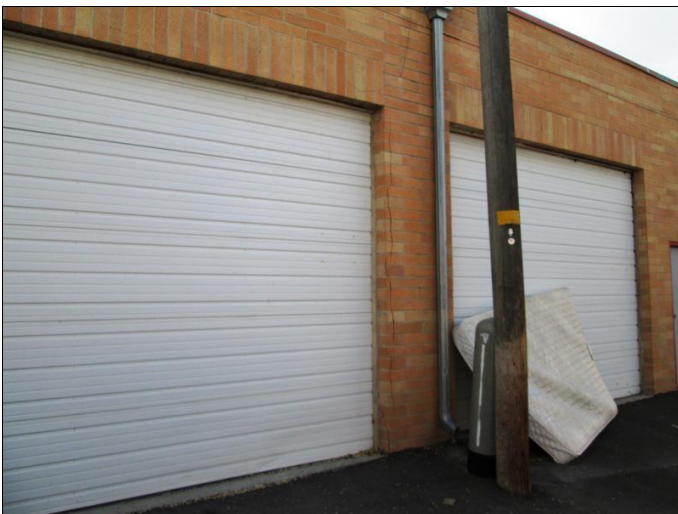
27. Telephone pole without bollard protection

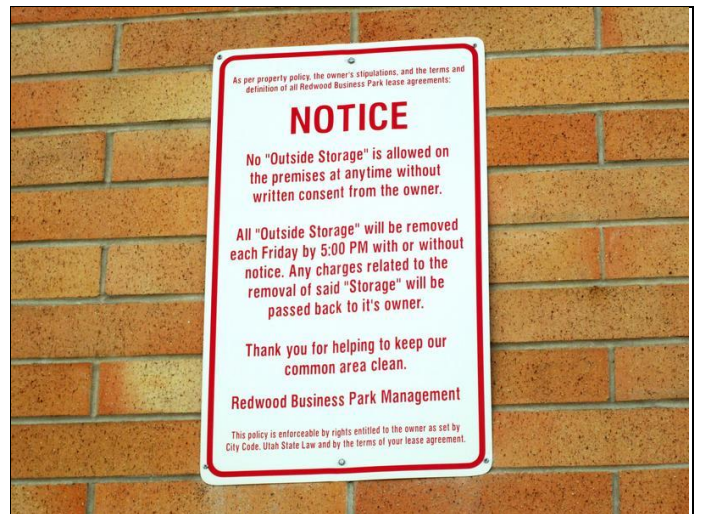
28. No "Outside Storage" is allowed sign

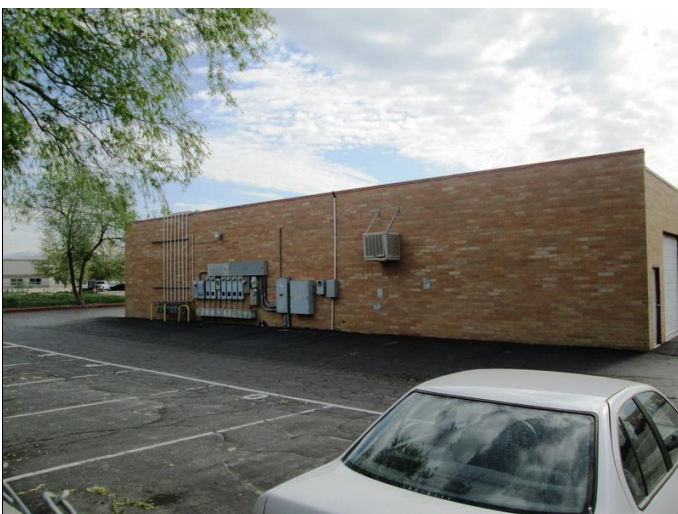
29. Pipe protection at gas meters at the west end of the 2852 Building

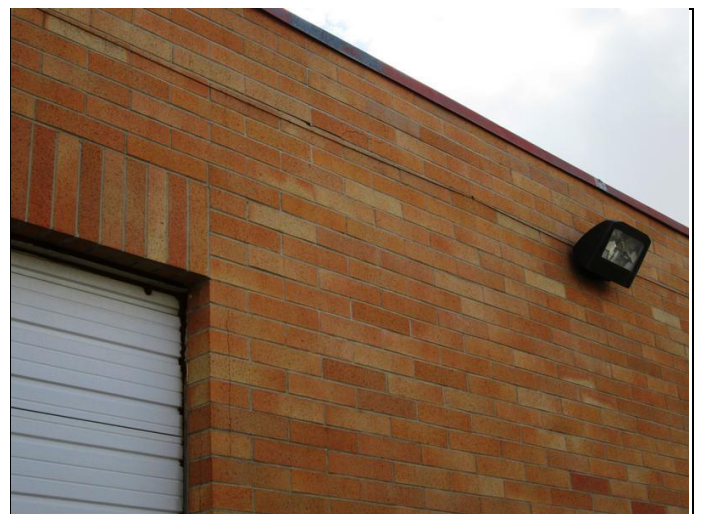
30. Typical wall-pack exterior lighting fixture

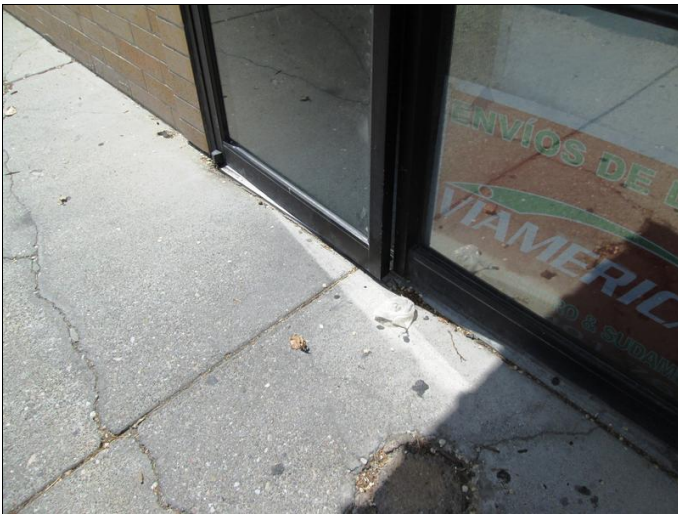
33. Deformed storefront frame set at entrance door to suite A11/A12 – Door does not swing closed

| SECT. # | ITEM | QTY | UNIT | UNIT COST | TOTAL COST | CONDITION |
|---|---|---|---|---|---|---|
| 4.4.3 | Replace storefront window-door sets | 4 | EA | \$750 | \$ 3,000 | The doors were noted to be in good overall condition; however, some of the storefront system doors were racked and difficult to open. Partner recommends adjustment of the affected doors. |

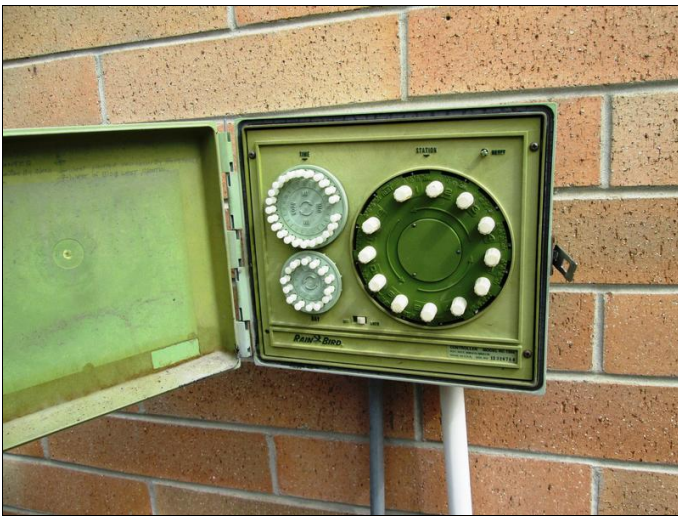
37. Irrigation timer controls at south end of Building 2850

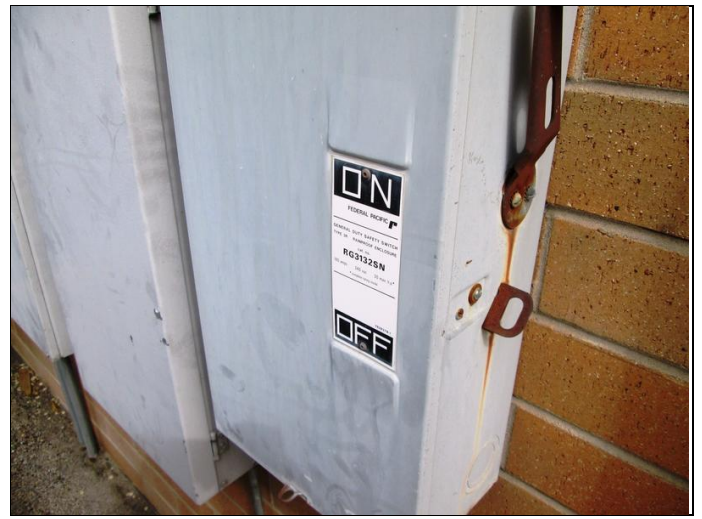
38. Main electrical shut-off at south end of Building 2850

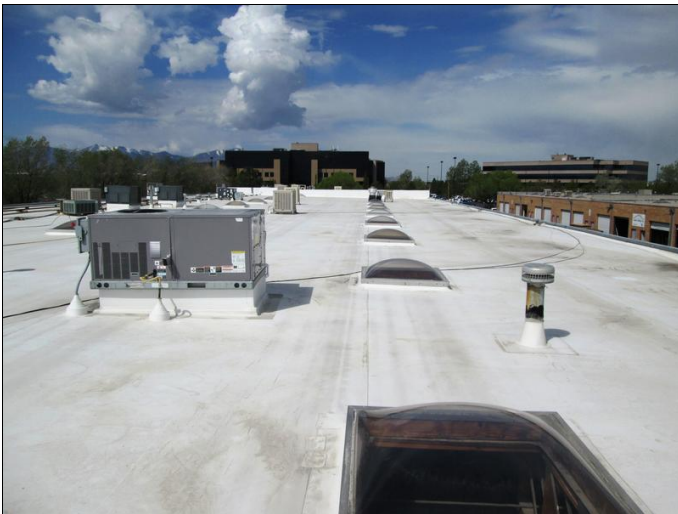
39. TPO roofing at Building 2854 looking west

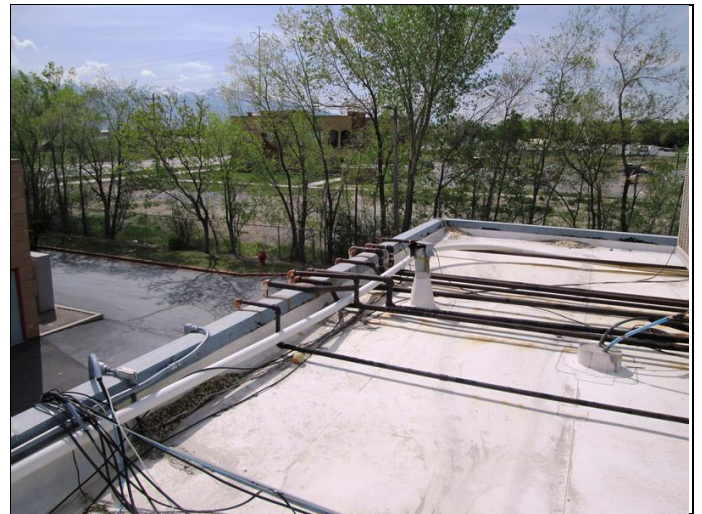
40. Typical gas line piping up exterior wall and over TPO roofing at Building 2854 (view southwest)

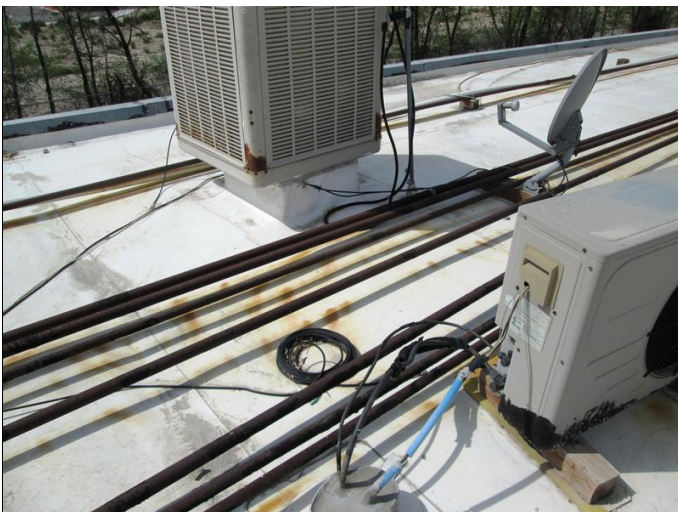
41. Natural gas piping over TPO roofing

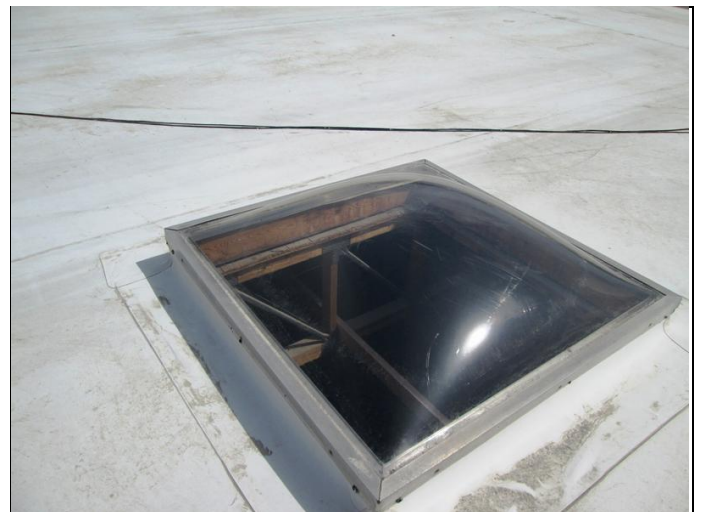
42. Typical aluminum frame skylight unit

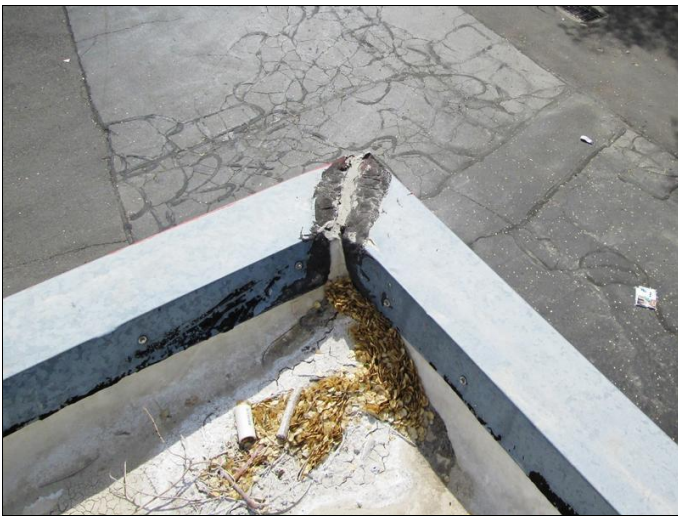
43. Detail view of parapet cap at corner, typical

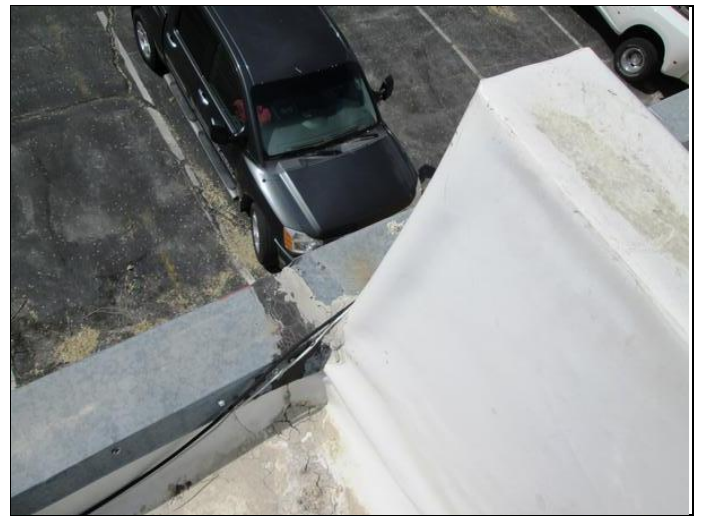
44. Parapet cap where it meets the fire wall above the roof at Building 2854

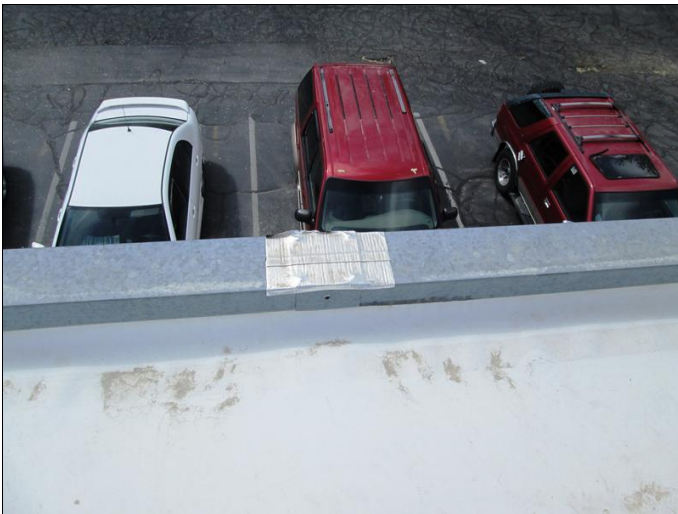
45. Duct tape patch at roof cap

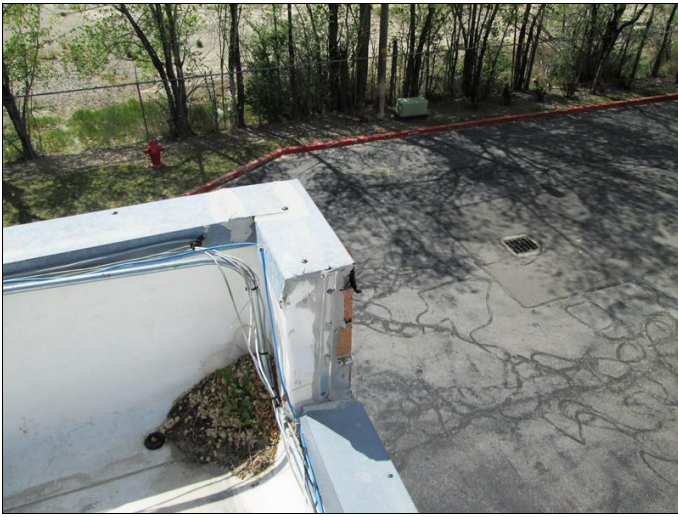
55. Parapet wall at Building 2850 southwest corner

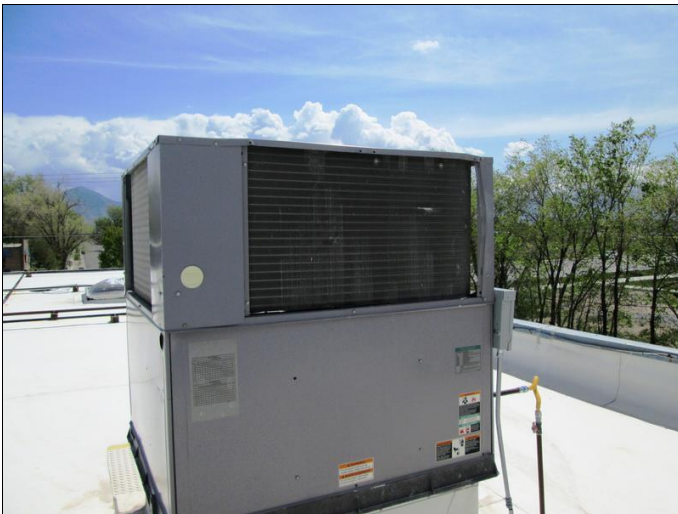
57. Package roof top unit above suite A11/A12 of Building 2850

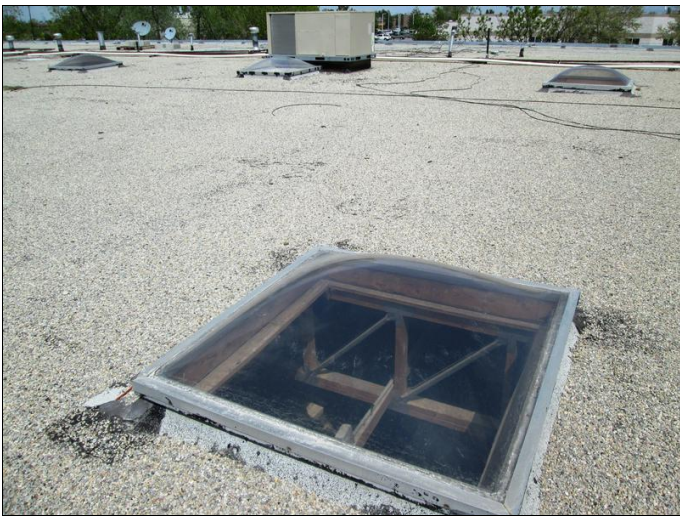
67. Skylight at Building 2852 with visible framing of structure below

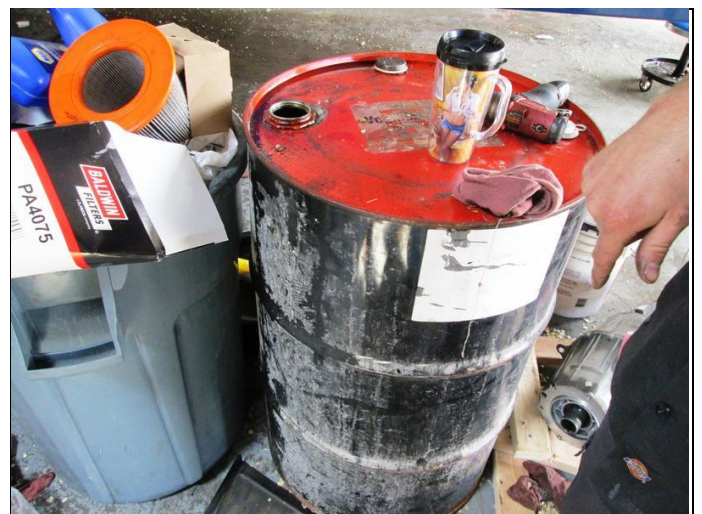
90. Barrel used for waste oil from autos

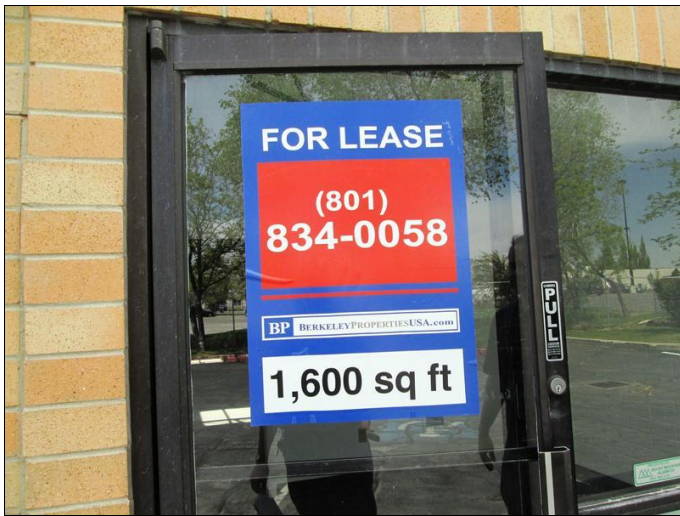
91. Lease sign at suite B1

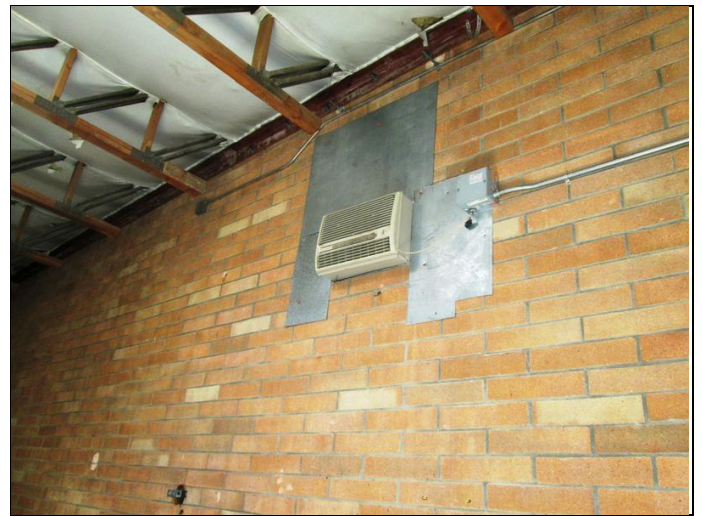
92. Through wall HVAC unit at far west wall of Building 2852, as seen from the interior

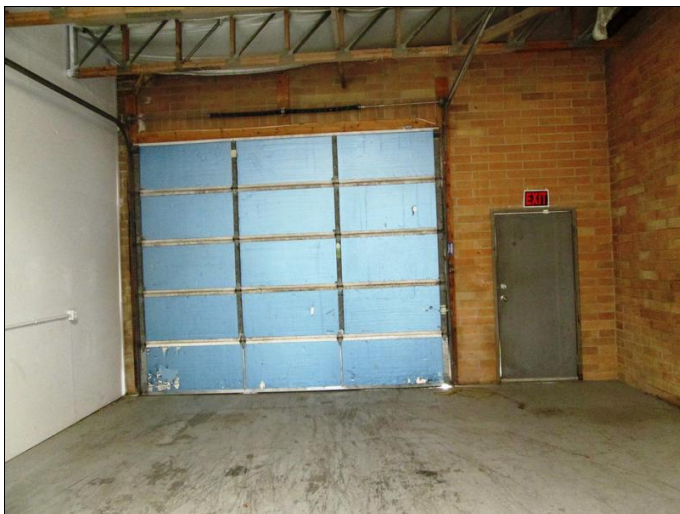
93. View of roll-up sectional door and service door exit at suite B1

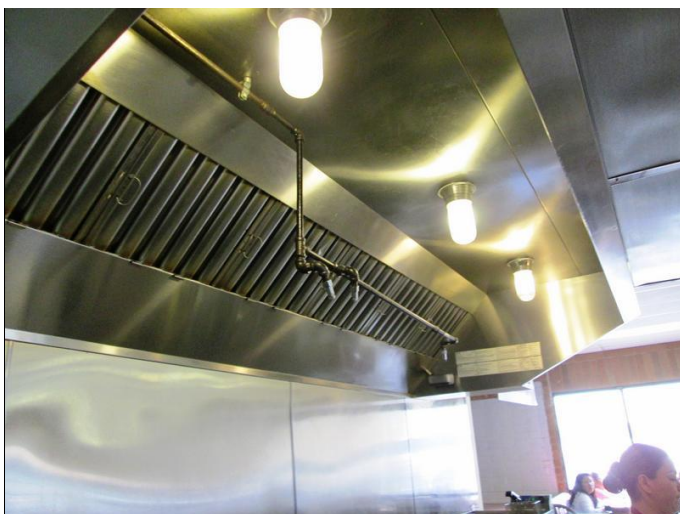
95. Exhaust hood above grill inside suite A11/A12

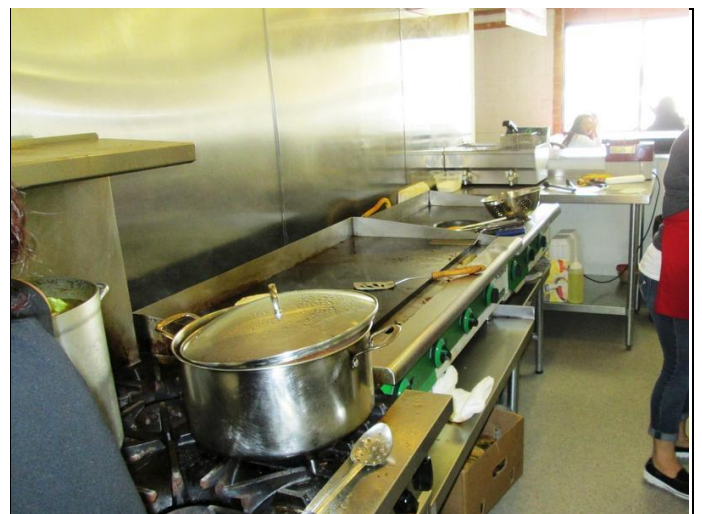
96. Grill inside suite A11/A12

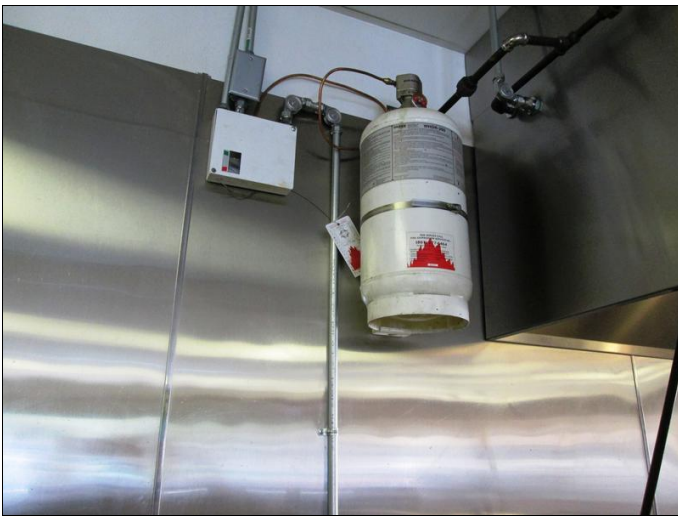
97. Fire suppression canister with current inspection tag for hood over grill inside suite A11/A12

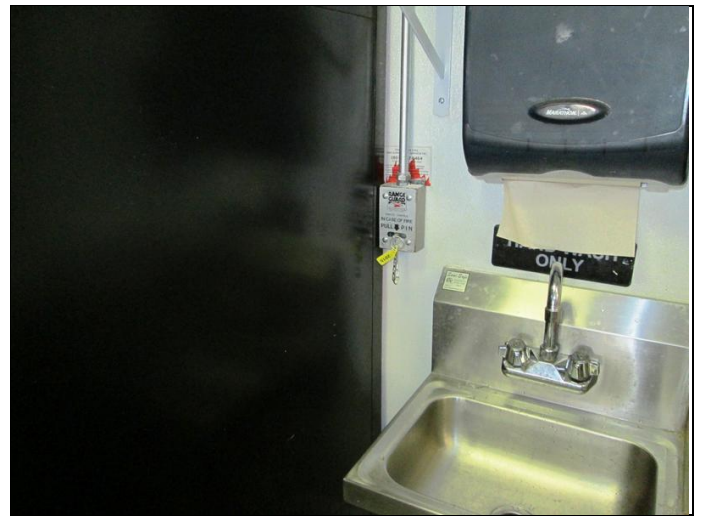
98. Fire suppression pull switch for hood over grill

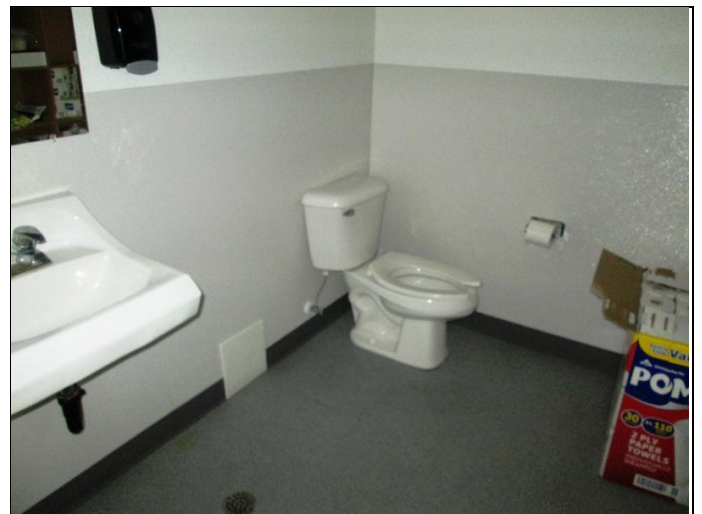
100. Employee restroom in suite A11/A12

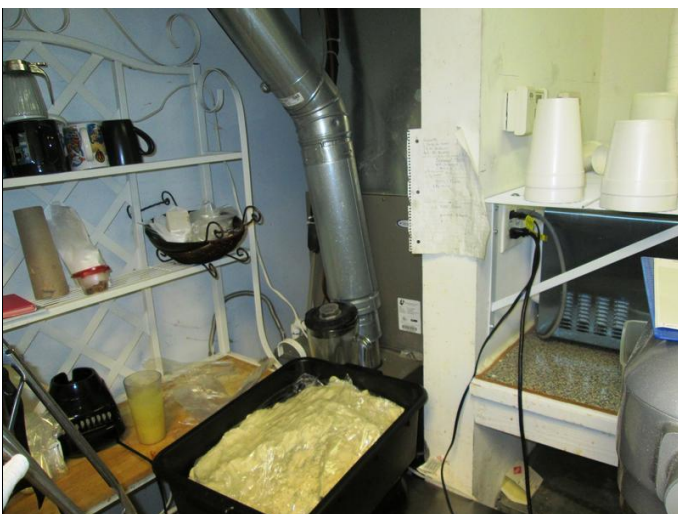
101. Furnace in suite A11/A12
